X-Ray Photoelectron Spectroscopy  
Study of Radiofrequency-Sputtered  
Titanium Carbide, Molybdenum Carbide,  
and Titanium Boride Coatings  
and Their Friction Properties

William A. Brainard and Donald R. Wheeler

OCTOBER 1977

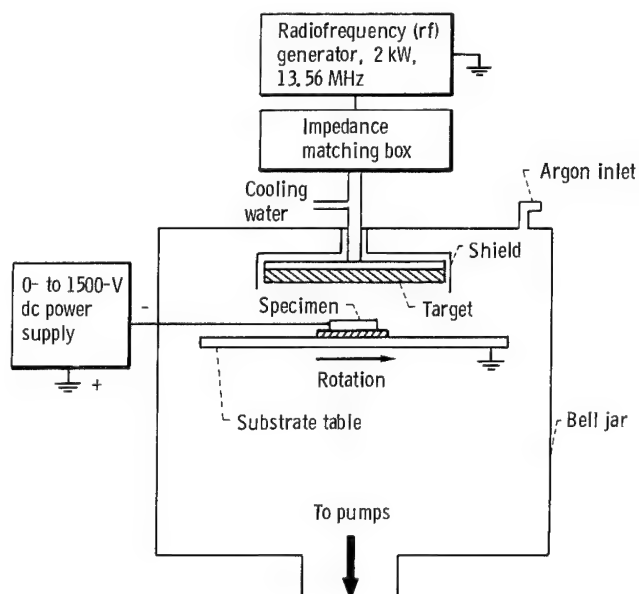
Figure 1. - Schematic of rf sputtering apparatus.

The sputtering of the materials used in this investigation was conducted in a commercial rf diode apparatus (fig. 1) operating at 13.56 megahertz. The material to be sputter deposited is in the form of a hot pressed compact which was commercially purchased. The specimen to be coated is placed 2.5 centimeters directly below the target on an electrically insulated block. An additional voltage from 0 to -1500 volts dc may be applied directly to the specimen either for specimen cleaning by dc sputter etching or for biasing the specimen during film deposition and growth. Provision is made for rotation

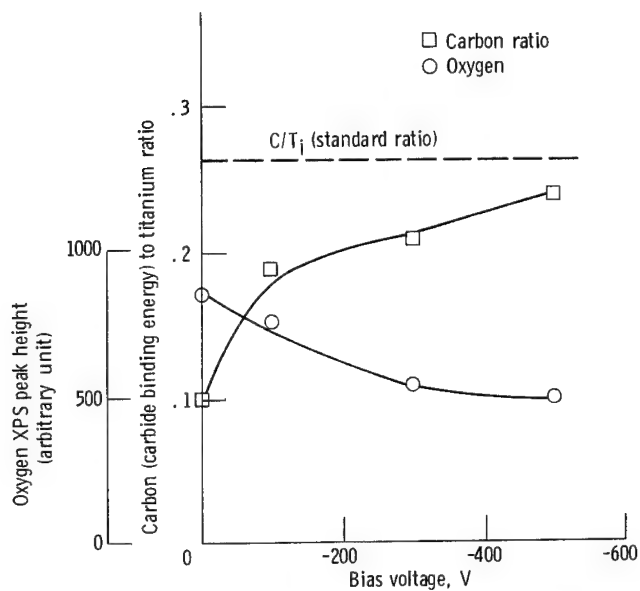
Figure 2. - Variation of oxygen (1s) XPS peak height and ratio of C(1s) to Ti(2p<sub>3/2</sub>) peak heights in sputtered TiC films as a function of substrate bias.

Figure 2 shows XPS data for sputtered TiC as a function of bias voltage. The composition closest to the standard (target material) and lowest oxygen concentration occurred at -500 volts, the same voltage as in the previous investigation (ref. 2). Figure 3 shows XPS peaks for the carbon (1s) and titanium ( $2p_{3/2}$ ) peaks at the two extremes of bias. As was observed in reference 3 for  $\text{CrB}_2$  and  $\text{MoSi}_2$  coatings, oxidation of one or both constituent elements has occurred with no external bias (grounded). The titanium oxide peak at 458.6 eV is large in the unbiased sample in contrast to the much smaller peak at -500-volt bias. This is evidenced in the figure by the filling in of the "valley" between the titanium doublet peak. In addition, the carbon peak at 285 eV for the 0-volt sample shows that, because of the formation of  $\text{TiO}_2$ , the carbon normally combined as carbide is in the free state. This accounts for the much lower carbide to titanium ratio without bias in figure 2, and partially explains the reported poorer friction performance of sputtered TiC coatings done without bias (ref. 2).

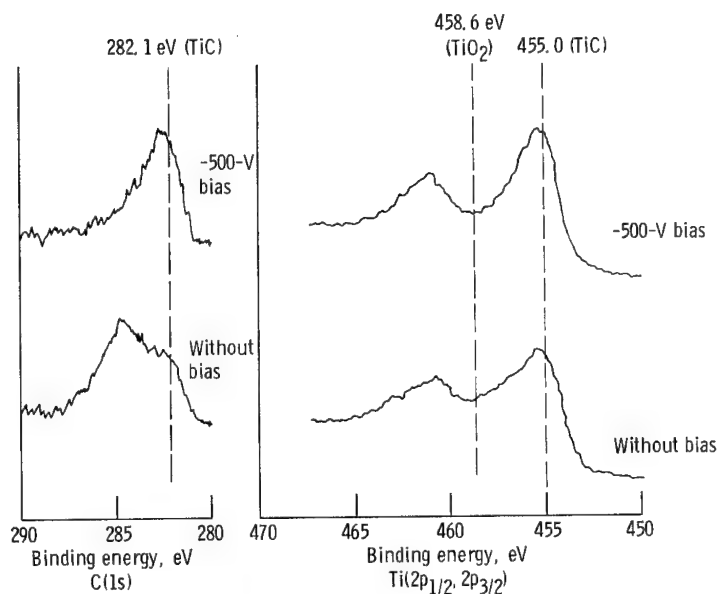
Figure 3. - Representative C(1s) and Ti(2p) XPS peaks from biased and unbiased TiC sputtered coatings.

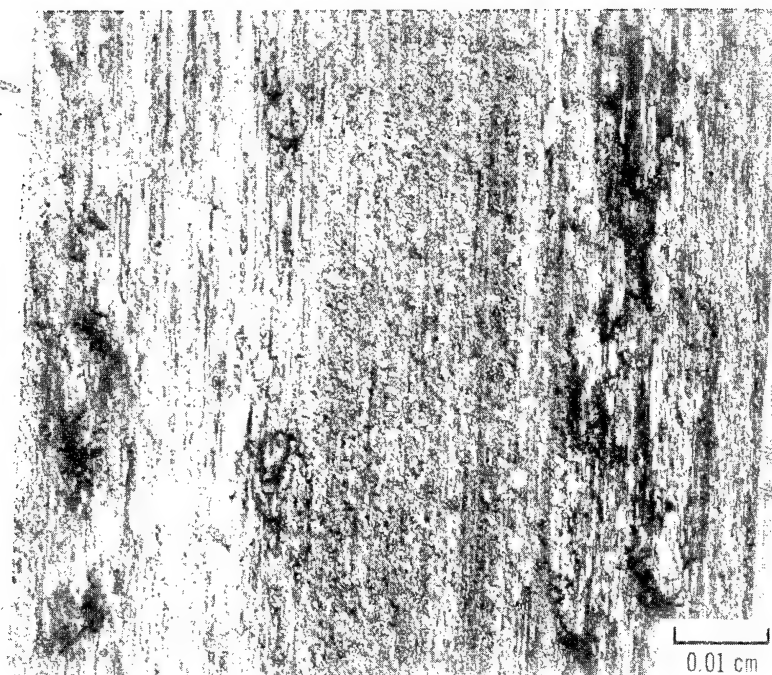
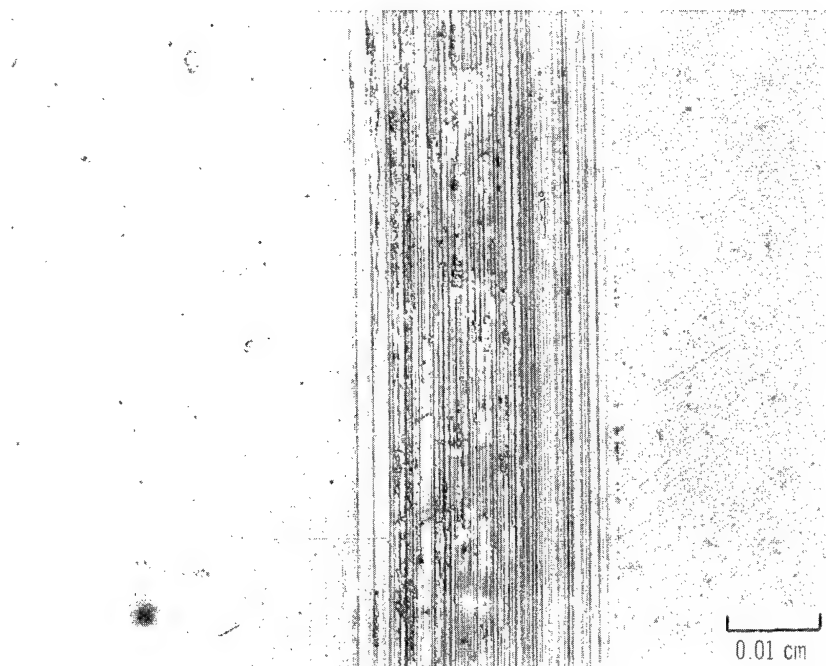
(a) 10% H<sub>2</sub>-90% Ar.

(b) 100% Ar.

Figure 4. - Disk wear tracks for 440-C disk rf sputter coated with TiC ( -500-V bias); rider, 304 stainless steel; load, 0.25 newton; sliding time, 30 minutes.

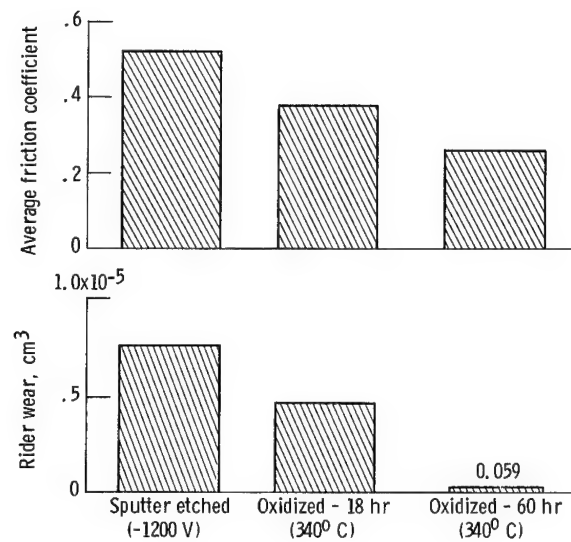
Figure 5. - Average friction coefficient and rider wear for 440-C disks rf sputter coated with TiC (-500-V bias); rider, 304 stainless steel; load, 2.0 newtons; sliding time, 60 minutes; N<sub>2</sub> atmosphere.

tion of an oxidized layer. No attempt was made to measure the oxide thickness or determine its composition. Figure 5 presents friction and wear data for TiC rf sputtered onto 440-C disks, one disk having been sputter etched at -1200 volts for 15 minutes to remove the normal oxidized layer, another deliberately preoxidized for 18 hours and the third preoxidized for 60 hours. The coatings were all applied under the same sputtering conditions. The results are clear. Lower friction and wear were obtained with TiC on the preoxidized substrates. These results are directly related to improved film adherence. Figure 6 shows surface profile tracings on the wear track on TiC coated 440-C at a 5-newton load for a sputter etched disk and preoxidized disk. The results are dramatic and represent a significant exception to the usual concept of a need for a rigorously precleaned surface prior to coating.

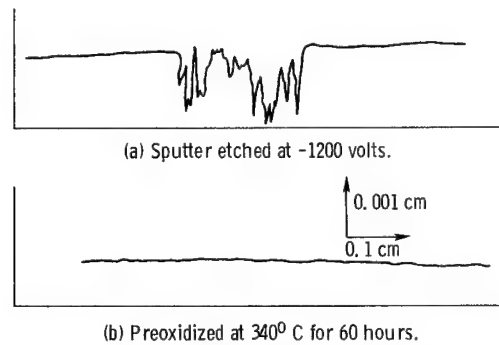
Figure 6. - Surface profile tracings of disk wear track for 440-C disk rf sputter coated with TiC (-500-V bias); load, 5 newtons; sliding time, 60 minutes; N<sub>2</sub> atmosphere.

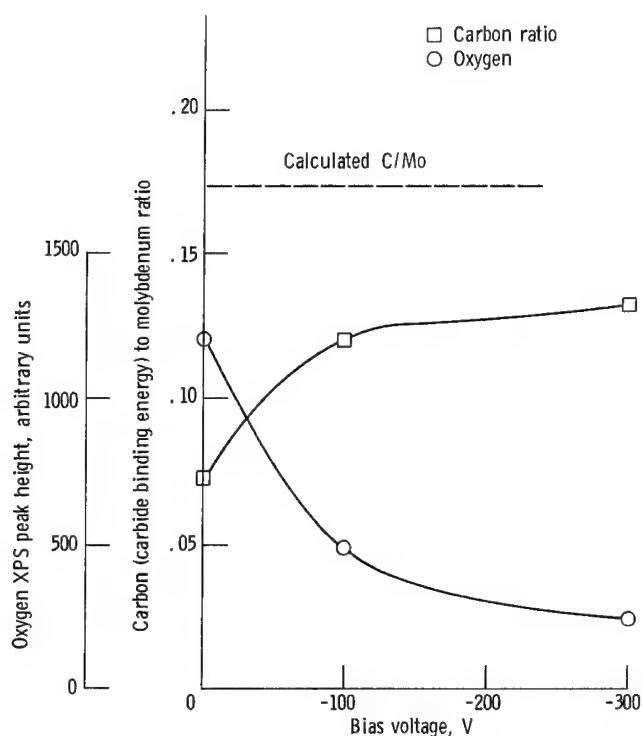
Figure 7. - Variation of oxygen (1s) XPS peak height and ratio of C(1s) to Mo(3d<sub>5/2</sub>) XPS peak heights in sputtered Mo<sub>2</sub>C films as a function of substrate bias voltage.

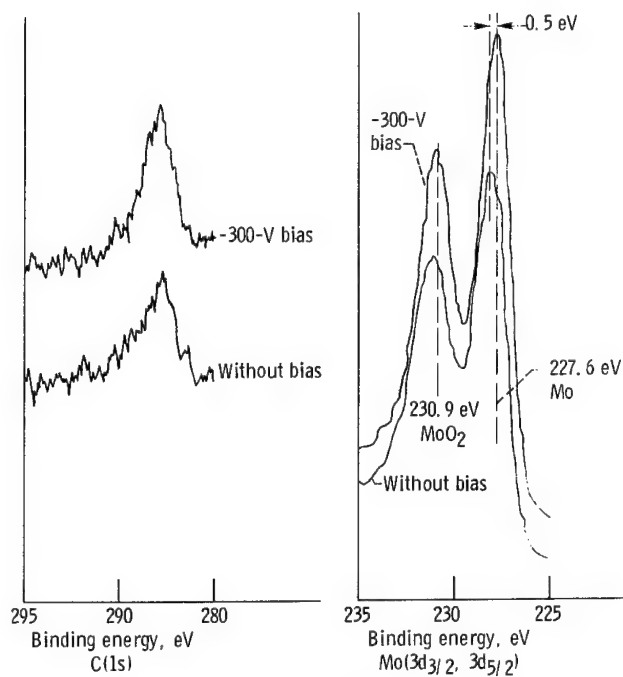
Figure 8. - Representative C(1s) and Mo(3d) XPS peaks from biased and unbiased Mo<sub>2</sub>C sputtered coatings.

Figure 8 shows the  $\text{C}(1s)$  and  $\text{Mo}(3d_{3/2}, 3d_{5/2})$  peaks taken from coating samples done at -300 volts and without bias. The size difference between the two molybdenum peaks for the two bias conditions are significant. The shift of the Mo peak without bias toward higher binding energy is very small (0.5 eV) but large enough to be greater than the instrumental error ( $\pm 0.3$  eV). The presence of a peak shifted to higher binding energy is confirmed by the filling in of the valley between the two Mo(3d) peaks in the unbiased case. A 0.5-eV shift has been observed previously on Mo foils exposed to air. We conclude that the shift is due to oxidation of the molybdenum yielding films that are really mixtures of oxides and carbides. Biasing at -300 volts significantly reduces the oxide yielding films with only about one-fifth the oxygen of films prepared without bias.

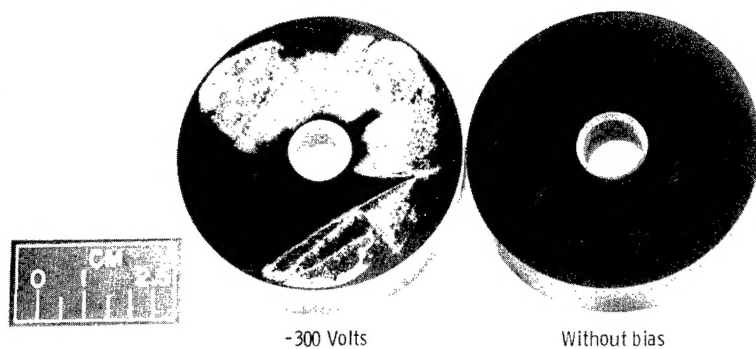
Figure 9. - Two 440-C disks sputter coated with  $\text{Mo}_2\text{C}$  at two bias conditions (disks precleaned by sputter etching at  $-1200\text{ V}$  for  $15\text{ min}$ ).

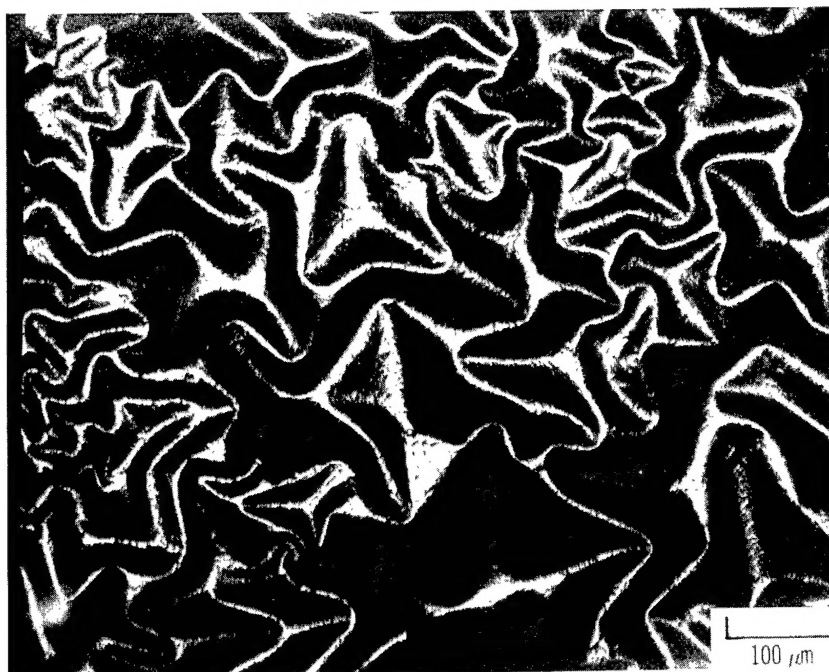
Figure 10. - Photomicrograph of surface of 440-C disk rf sputter coated with  $\text{Mo}_2\text{C}$  ( $-300\text{-V}$  bias). Disk sputter etched ( $-1200\text{ V}$  for  $15\text{ min}$ ) prior to coating.

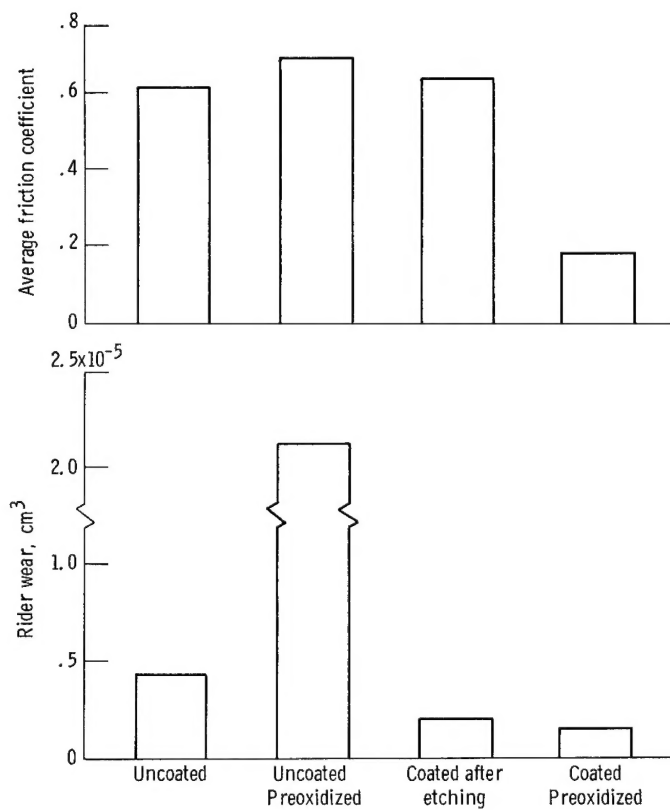
Figure 13. - Average friction coefficient and rider wear for 440-C disks either sputter etched ( $\sim 1200$  V for 15 min) or oxidized (20 hr at  $340^\circ$  C). Coated disks are rf sputtered with  $\text{TiB}_2$  ( $\sim 300$ -V bias); load, 0.5 newton; sliding time, 30 minutes;  $\text{N}_2$  atmosphere.

Note in figure 13 that deliberately oxidizing the 440-C for 20 hours at  $340^\circ\text{C}$  produced an increase in friction over the unoxidized sample and a fivefold increase in rider wear. The increase in wear and, to some extent friction, no doubt is related to the formation of hard metallic oxides (e.g.,  $\text{Cr}_2\text{O}_3$  and  $\text{Fe}_2\text{O}_3$ ).
